Comparative Performance Testing

Genuine Lexmark Unison Toner

versus Third-Party Toners in the Lexmark MS610 Printer

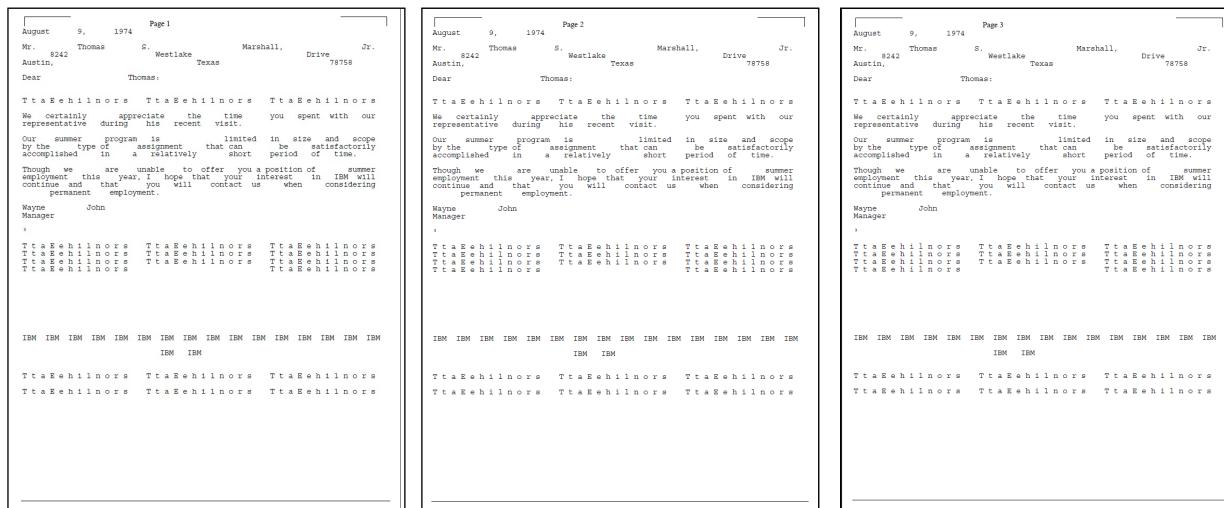
A three-page document with roughly 2.8% coverage was used throughout BLI's cartridge testing.

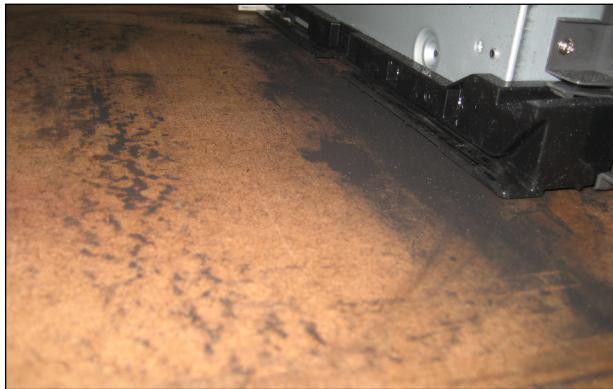
Halfway through BLI's testing, the machine dedicated to Brand #4 toner cartridges showed excessive toner spillage on the desktop around the device. Other third-party brands showed similar toner leakage during testing.

According to Lexmark engineers, this excessive toner leakage can likely be attributed to toner system inefficiency and failure of the J-seals in the imaging unit due to toner build-up, which bends the seals out of alignment, creating further contamination.

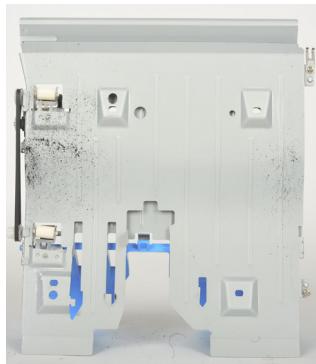
After printing 244,325 pages, the paper path from the printer using only genuine Lexmark Unison Toner was relatively clean, with very little toner spillage visible.

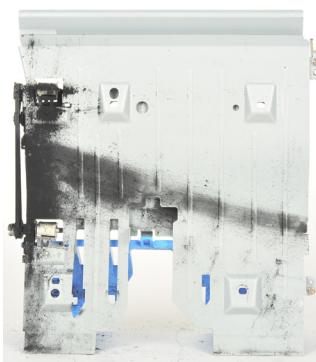
After printing 96,895 pages, the paper path from the printer using Brand #1 cartridges shows moderate toner leakage on one side and mild leakage on the other side.

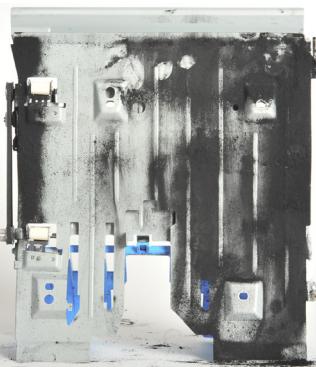
After printing 219,946 pages, the printer using Brand #2 cartridges shows heavy toner leakage across both sides of the paper path.

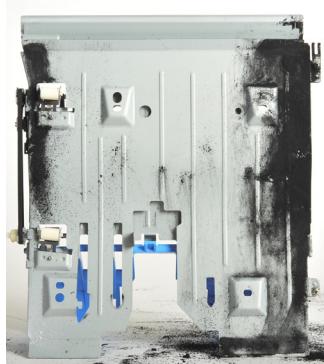
After printing 241,150 pages, the paper path from the printer using Brand #3 cartridges shows mild toner leakage on one side and moderate to heavy leakage on the other side.

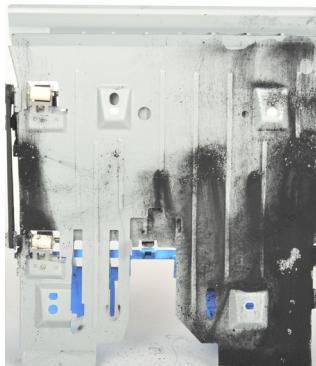
After printing 223,719 pages, the printer using Brand #4 cartridges shows mild toner leakage on one side and heavy leakage on the other side of the paper path.

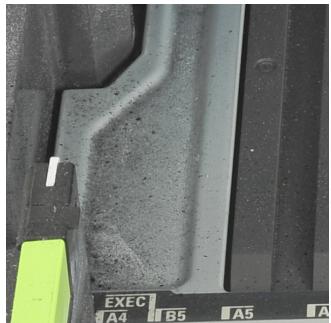
At the end of testing, the paper drawer from the printer using only genuine Lexmark Unison Toner was relatively clean, with very little toner spillage visible.

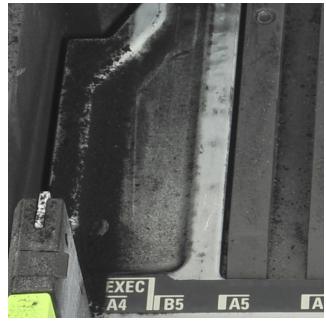
The printer using Brand #1 cartridges shows heavy toner leakage inside the paper drawer.

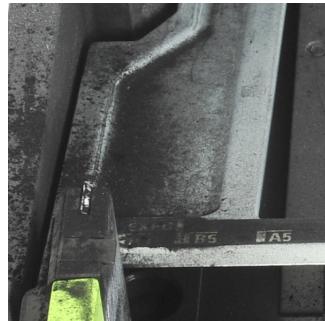
The printer using Brand #2 cartridges shows moderate toner leakage inside the paper drawer.

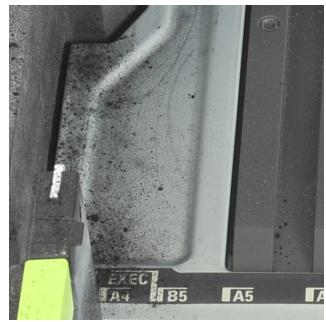
The printer using Brand #3 cartridges shows mild toner leakage inside the paper drawer.

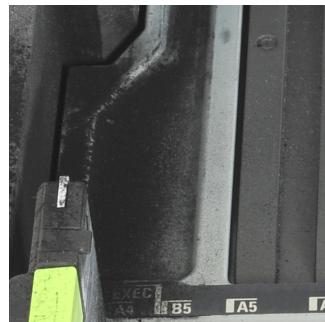
The printer using Brand #4 cartridges shows heavy toner leakage inside the paper drawer.

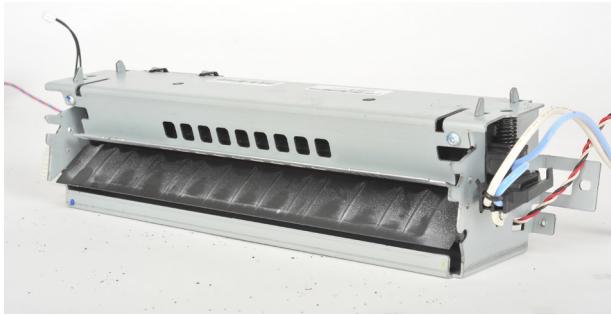
The fuser from the printer dedicated to only genuine Lexmark Unison Toner cartridges shows only paper dust, as would be expected, with no toner contamination on the unit.

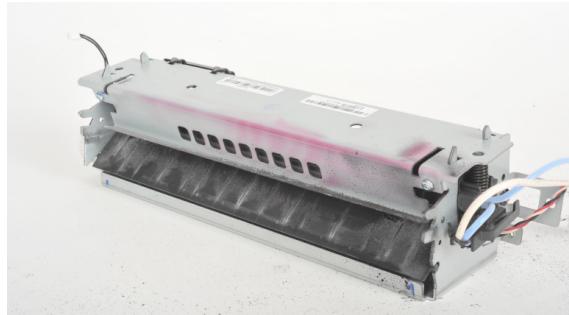
The fuser from the printer dedicated to Brand #4 cartridges, on the other hand, showed not only toner contamination but evidence of some type of pinkish/reddish contamination, too.

The fuser that was removed from the Brand #4 test printer exhibited a pinkish/reddish tint not normally seen on a fuser. Because of its location within the printer, the fuser is not visible to end users or service technicians without removal. Because the Lexmark MS610dn uses only black toner, it is unclear what caused the color change, and BLI analysts were unable to find material data safety sheets for any of the third-party cartridge brands tested.

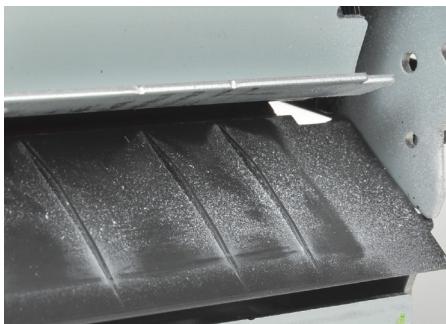
The Fuser Paper Entry Guides found on the MS610 fuser unit that used only genuine Lexmark Unison Toner cartridges show only normal paper dusting (visible as white specs) is evident on the fuser paper entry guide. The fuser using only genuine Lexmark Unison toner entry guides are free of visible toner residue.

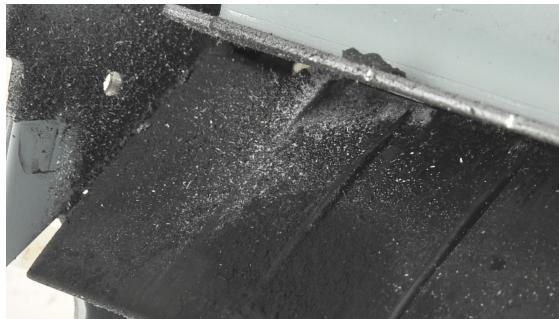
The printer using Brand #1 cartridges shows moderate toner contamination on the fuser entry guide.

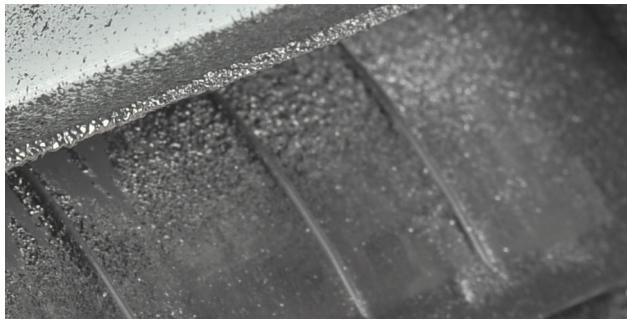
The printer using Brand #2 cartridges shows heavy toner contamination on the fuser entry guide, with large areas of melted toner across multiple surfaces of the guide.

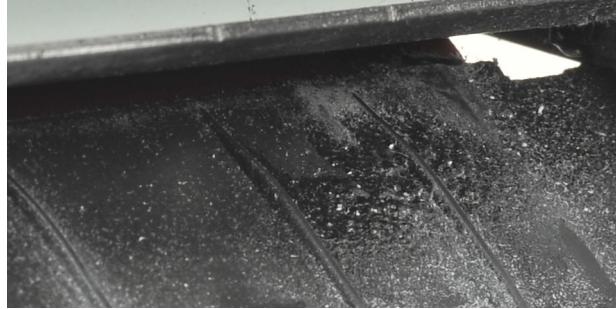
The printer using Brand #3 cartridges shows moderate toner contamination on the fuser entry guide, with areas of melted toner on some areas of the guide.

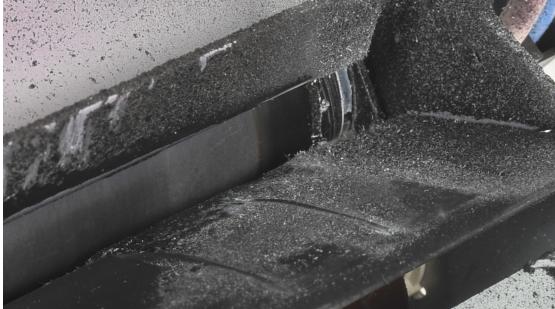
The printer using Brand #4 cartridges shows heavy toner contamination on the fuser entry guide, with large areas of melted toner across multiple surfaces of the guide.

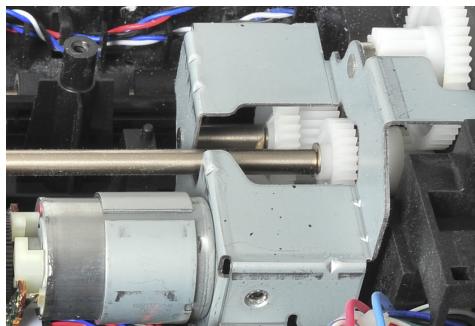
After printing 244,325 pages, the electrical/mechanical components from the printer using only genuine Lexmark Unison Toner was clean, with little to no toner contamination visible.

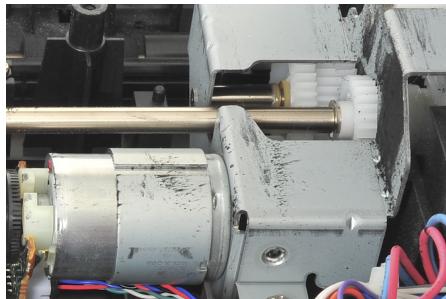
The printer using Brand #1 cartridges shows moderate toner leakage within the mechanical/electrical system.

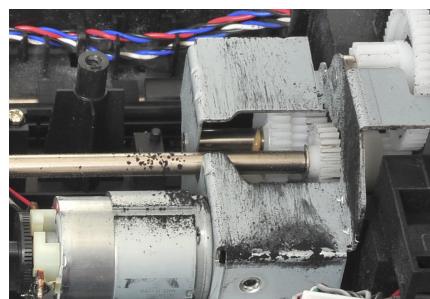
The printer using Brand #2 cartridges shows moderate to heavy toner leakage within the mechanical/electrical components, including in the gear system, which could lead to performance issues.

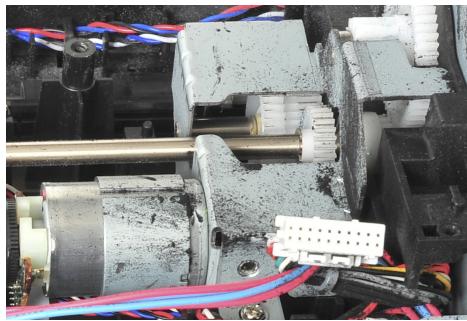
The printer using Brand #3 cartridges shows moderate to heavy toner leakage within the mechanical/electrical components, including in the gear system, which could lead to performance issues.

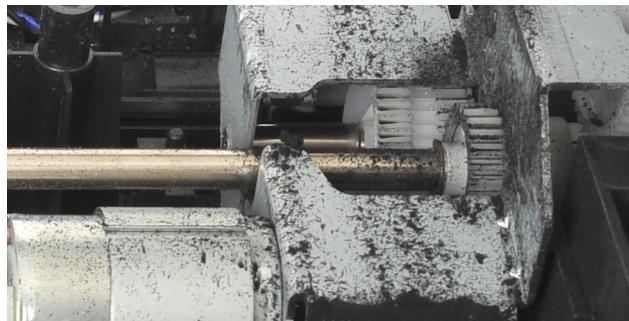
The printer using Brand #4 cartridges shows heavy toner contamination throughout the mechanical/electrical components, including in the gear system, which could lead to performance issues.

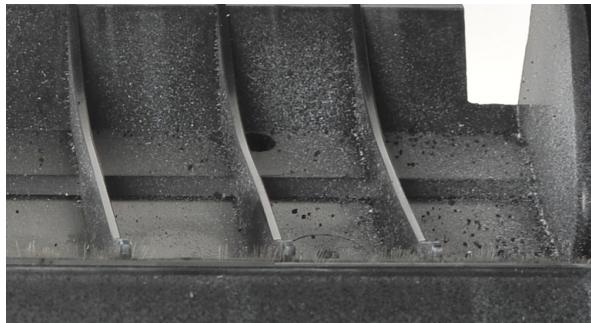
At the end of testing, the internal paper feed guide from the printer using only genuine Lexmark Unison Toner was relatively clean, with very little toner spillage visible.

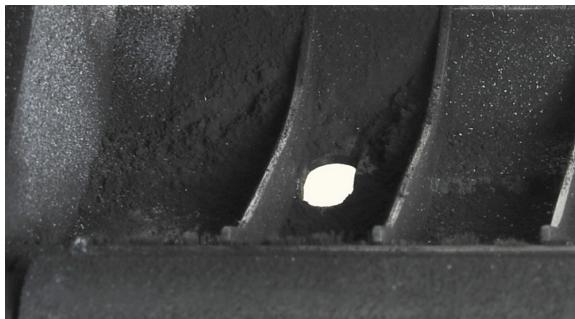
The printer using Brand #1 cartridges shows moderate to heavy toner build-up across the paper feed guide.

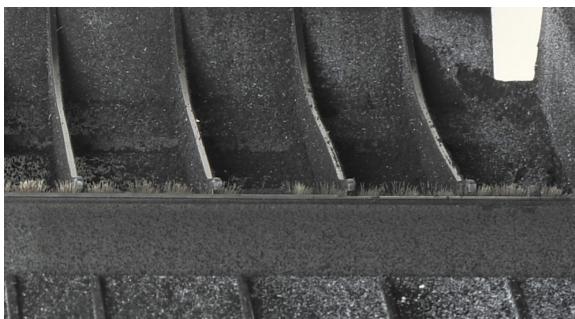
The printer using Brand #3 cartridges shows light to moderate toner build-up across the paper feed guide.

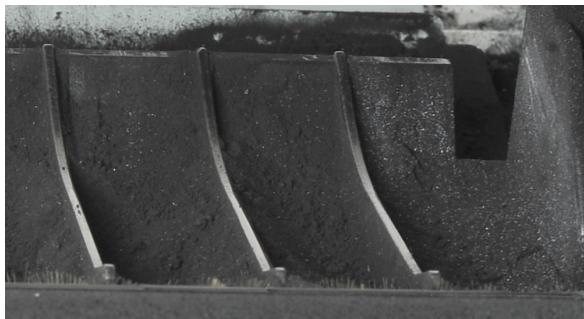
The printer using Brand #2 cartridges shows significant/heavy toner build-up across the paper feed guide.

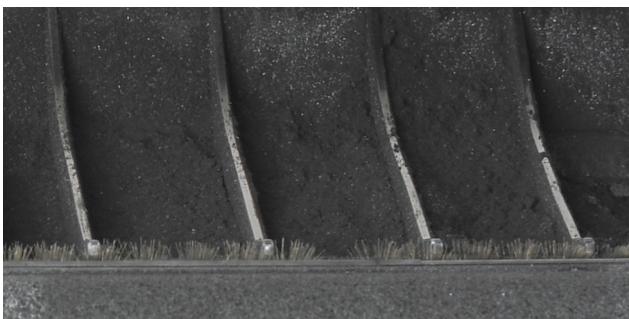
The printer using Brand #4 cartridges shows moderate to heavy toner build-up across the paper feed guide.

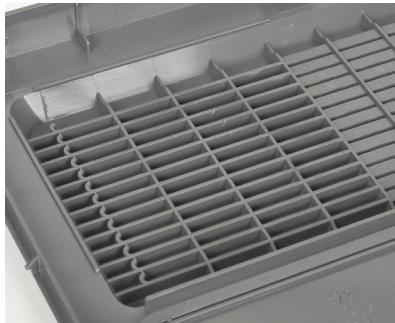
The test printer using genuine Lexmark Unison Toner cartridges showed no toner residue, indicating proper toner containment throughout the 244,373 page test cycle.

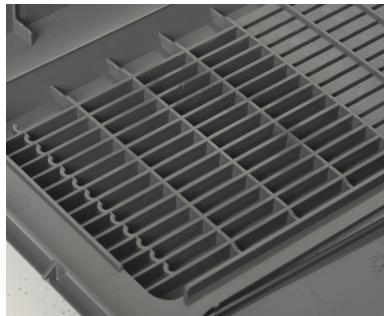
The printer using Brand #1 cartridges shows showed light toner residue after printing 96,895 pages.

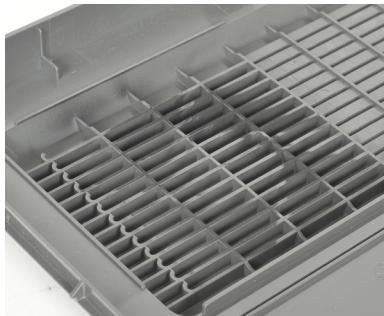
The printer using Brand #2 cartridges shows light to moderate toner residue on the vent cover.

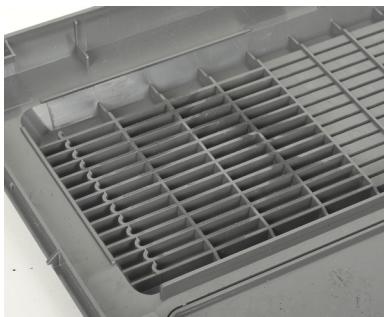
The printer using Brand #3 cartridges shows light to moderate toner residue on the vent cover.

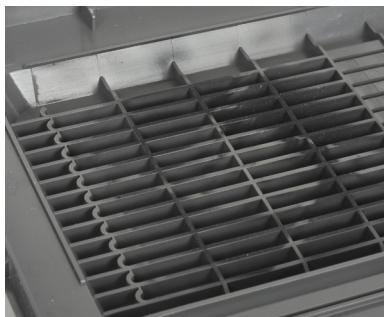
The printer using Brand #4 cartridges shows moderate to heavy toner residue on the vent cover.

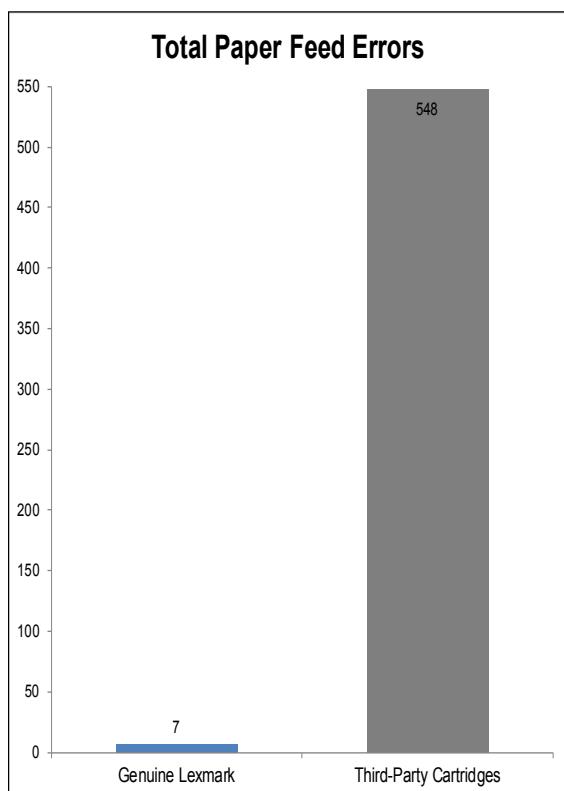
Overall Reliability Summary for 80-Day Test Duration

GENUINE LEXMARK UNISON TONER		
DESCRIPTION	ERROR CODE	NUMBER OF OCCURRENCES
Fuser Exit Sensor	202.xx	7
Total Paper Feed Errors		7
THIRD-PARTY BRANDS TESTED		
DESCRIPTION	ERROR CODE	NUMBER OF OCCURRENCES
Electrical Interference Toner Density Sensing System	132.xx	3
Input Sensor, Exit Sensor Page Error - Paper failed to move through system normally	200.xx, 202.xx	50
Auto Duplex Feed Errors	230.xx, 232.xx	494
Paper Tray Feed Errors	241.xx	1
Total Third-Party Feed Errors		548

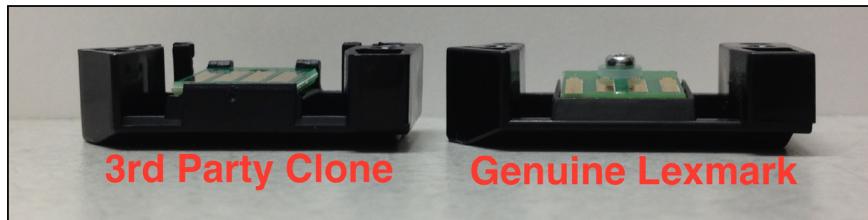
Because the chip interconnect on the clone cartridge (left) is angled differently than the original Lexmark chip interconnect (right), the clone cartridge caused damage to the printer.

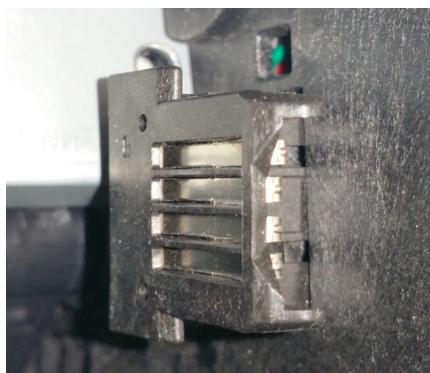
Before installation of the clone cartridge, the pins on the chip sensor are visible and intact.

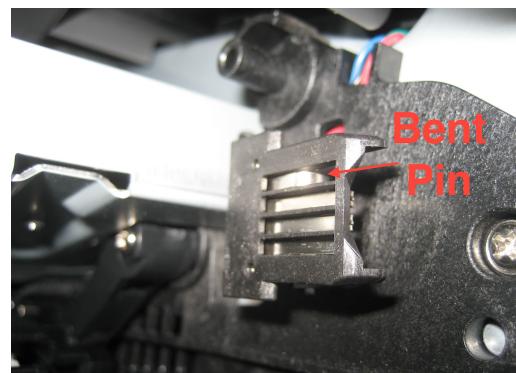
After installation of the clone cartridge, the pins on the sensor have been bent back and damaged.

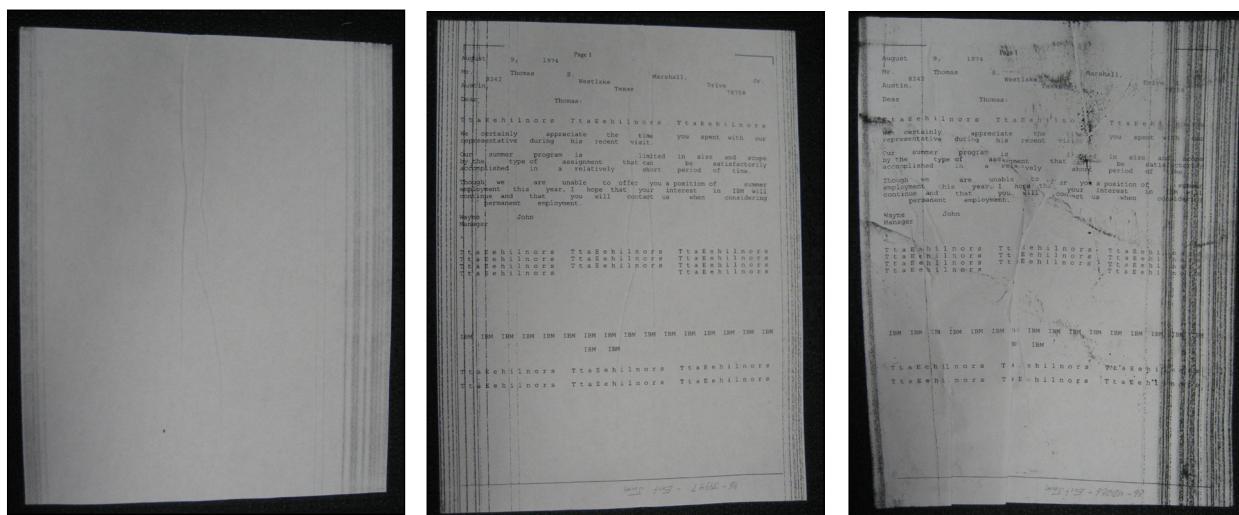
PRINT QUALITY SAMPLES: Brand #1

Pages produced using Brand #1 cartridges exhibited wrinkling and moderate to heavy toner streaking at the edges of pages (on both the front and back of pages).

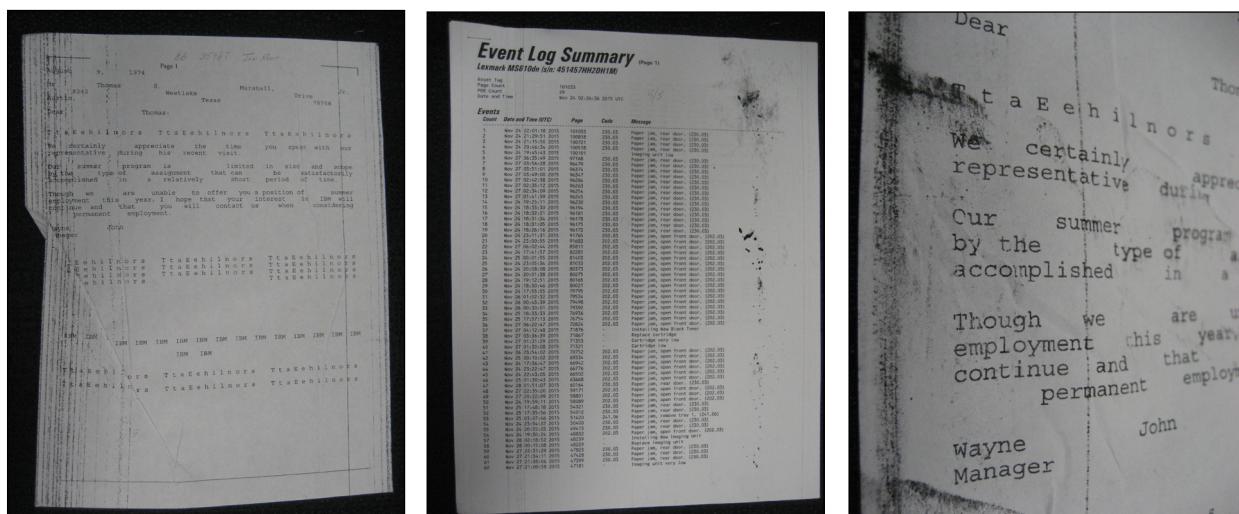
PRINT QUALITY SAMPLES: Brand #2

Pages produced using Brand #2 cartridges exhibited wrinkling, toner flaking, spotting and light to moderate streaking throughout testing.

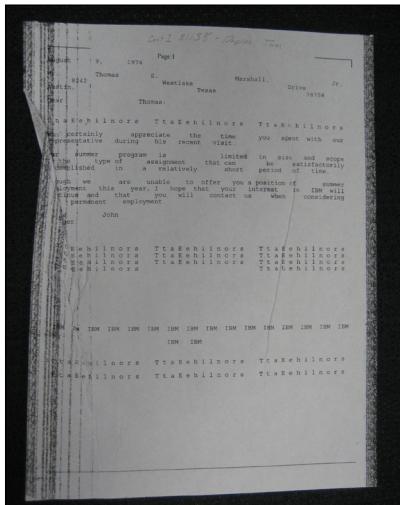
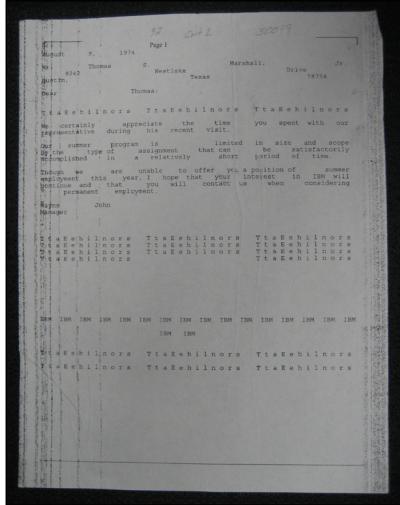
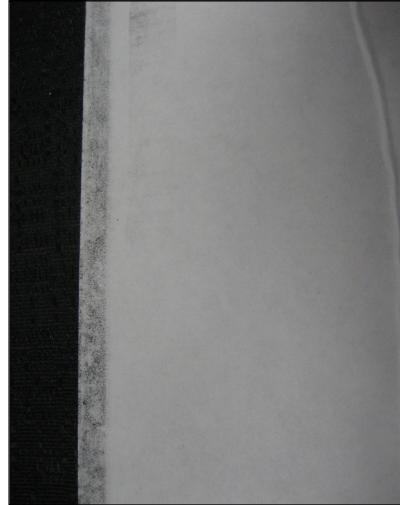
PRINT QUALITY SAMPLES: Brand #3

Pages produced using Brand #3 cartridges exhibited wrinkling and moderate to heavy toner streaking on the edges of pages (on both the front and back of pages).

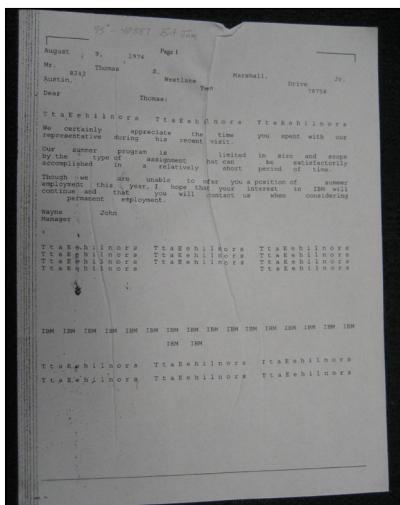
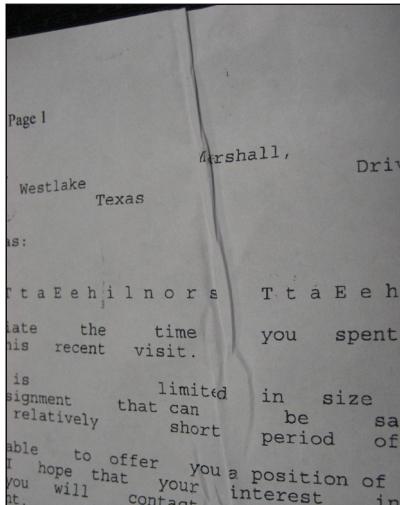
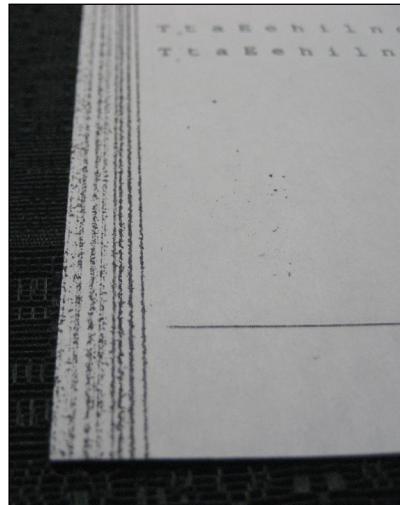
PRINT QUALITY SAMPLES: Brand #4

Pages produced using Brand #4 cartridges exhibited severe wrinkling and light to moderate toner spotting and streaking on the left edge of pages.
